Supplementary materials for

Temporal changes in surface afterslip along the 2016

5 Kumamoto earthquake rupture revealed by repeated field surveys

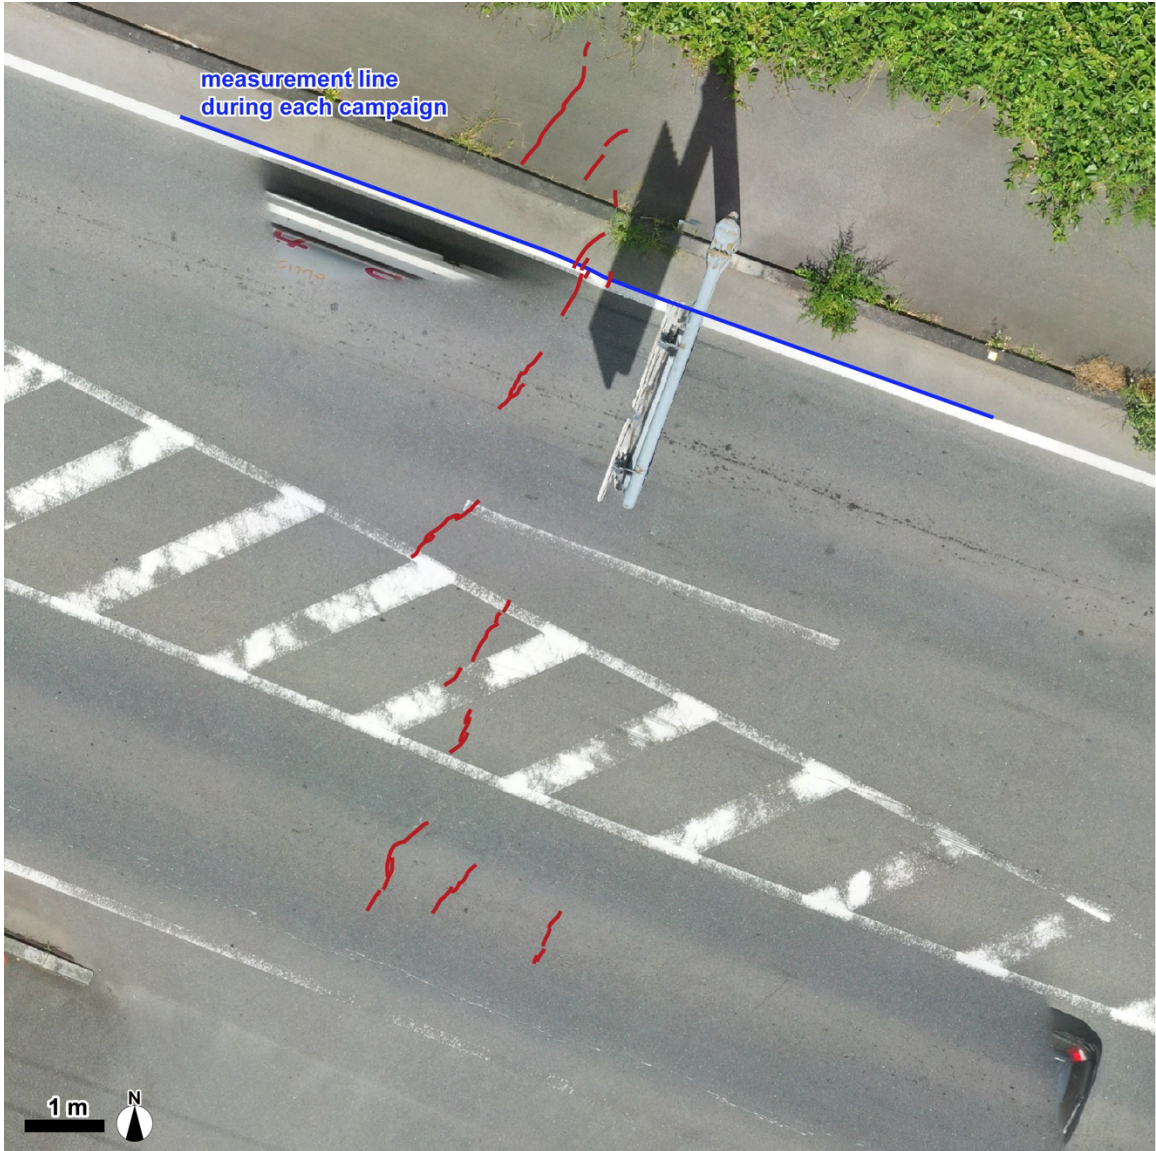
25 Figure S1. Distribution of the cracks associated with the postseismic surface deformation at Loc. 2 in Oike. Red lines indicate the distribution of the cracks. Basemap is the orthographical image created using a drone image taken on 8 August 2022.

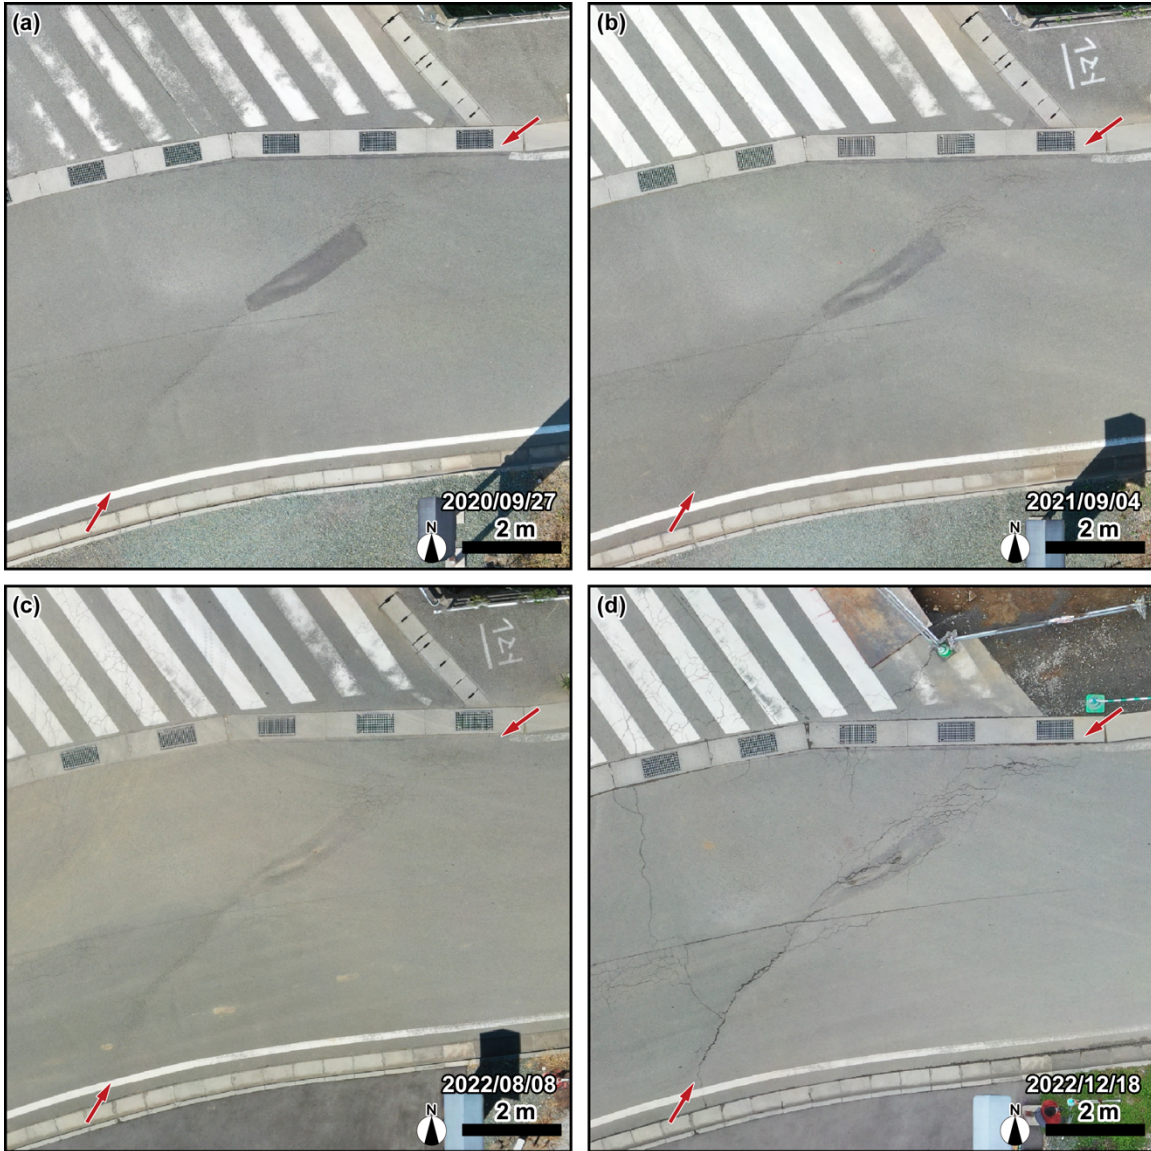
30 Figure S2. Temporal changes in the small graben-like depression at Loc. 3 in Takaki. Basemap is the orthographical image created using a drone image taken on 27 September 2020, 4 September 2021, 8 August 2022, and 18 December 2022, respectively. As time passes, the depression was growing to the northeast within the repaired patch of pavement. When we visited on 26 September 2023, the entire road surface had been completely repaired, and we were unable to observe the depression.

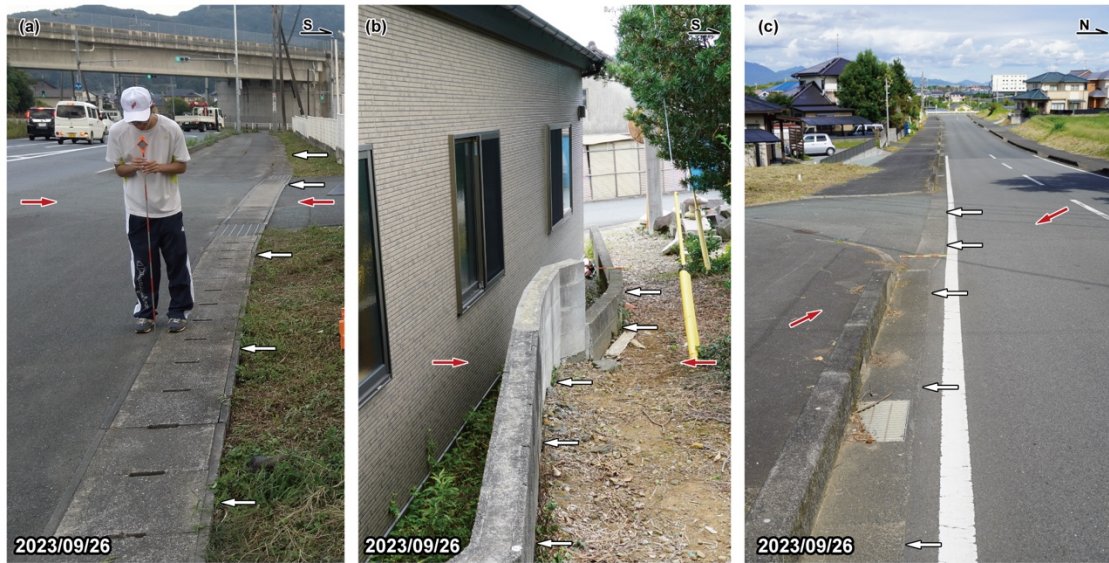
Figure S3. Photographs of the cumulative displacement of coseismic and postseismic surface deformation along the Hinagu fault. (a) Displacement at 15 m south of Loc. 2. (b) Displacement at 140 m north of Loc. 6. (c) Immediately south of Loc. 7 (White line). Red arrows indicate the location of the surface ruptures associated with the mainshock of the Kumamoto earthquake.
